Structural Report

Sidestrand Hall School, Sidestrand – Full Planning Application for demolition and rebuilding of chimney, including replacement of existing steel supports

Project name:	Sidestrand Hall School – Works to Chimney
Date:	20/05/2024
Author:	██████████ BEng (Hons) CEng MIStructE
Owner:	Structural
Client:	Norfolk County Council – Children’s Services

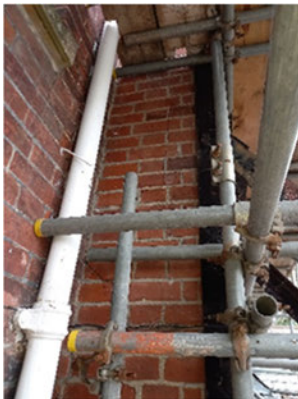
During refurbishment works to the hall roof, scaffold access was available to the areas surrounding the chimney. On close inspection, it became evident that the masonry chimney is suffering from significant structural cracking, and the existing steel bracing to the chimney is extensively corroded.

▲ *Cracking to chimney structure*

In addition to the above, there is significant visible evidence of structural cracking damage, both internally and externally to the walls that adjoin the chimney and form the external chimney walls respectively. This cracking is most likely evidence of damage that occurred to the chimney and adjoining masonry superstructure prior to the steel bracing being added, probably instigating the decision to provide steel bracing in the first place due to concerns over safety.

The preferred option would be to carefully demolish all external sides of the chimney to the existing plant room flat roof level, and rebuild the chimney structure in the same position, strengthening & re-stitching the damaged masonry as it is rebuilt. This would remove the need for any cracking repairs to the external facing brickwork. The steelwork could then be removed fully at the same time, allowing full access for repairs and final replacement in full sections to match existing.

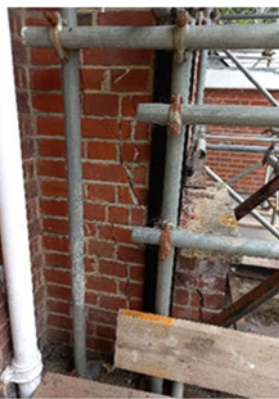
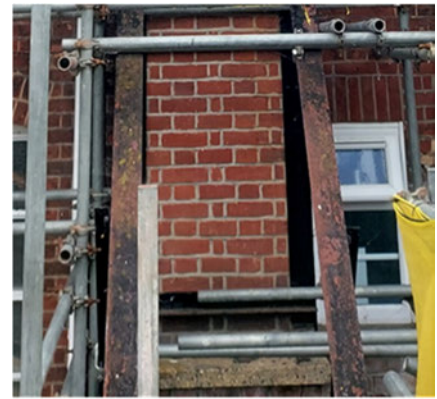
▲ *Corroded steel supports*

Although the chimney will be rebuilt to address the cracking issue, external steel bracing would still be required to provide structural integrity & support to the chimney to ensure Building Regulations Part A – Structure compliance. This will follow the same principal as is currently installed in terms of steel section details and design. The steelwork will however be powder coated to help prevent against future corrosion.

Therefore, from a structural safety perspective, and in accordance with Building Regulations Part A – Structure compliance requirements, the chimney must be provided with additional support and it is therefore our recommendation that the existing steel bracing is retained, albeit as a like for like replacement steel frame due to the significant corrosion to the existing steelwork.
