# **Norwich Western Link**

**A10 WEST WINCH HOUSING ACCESS ROAD**

**STAGE 1 SAFETY AUDIT**

**REPORT REF: A10/015  
November 2023**

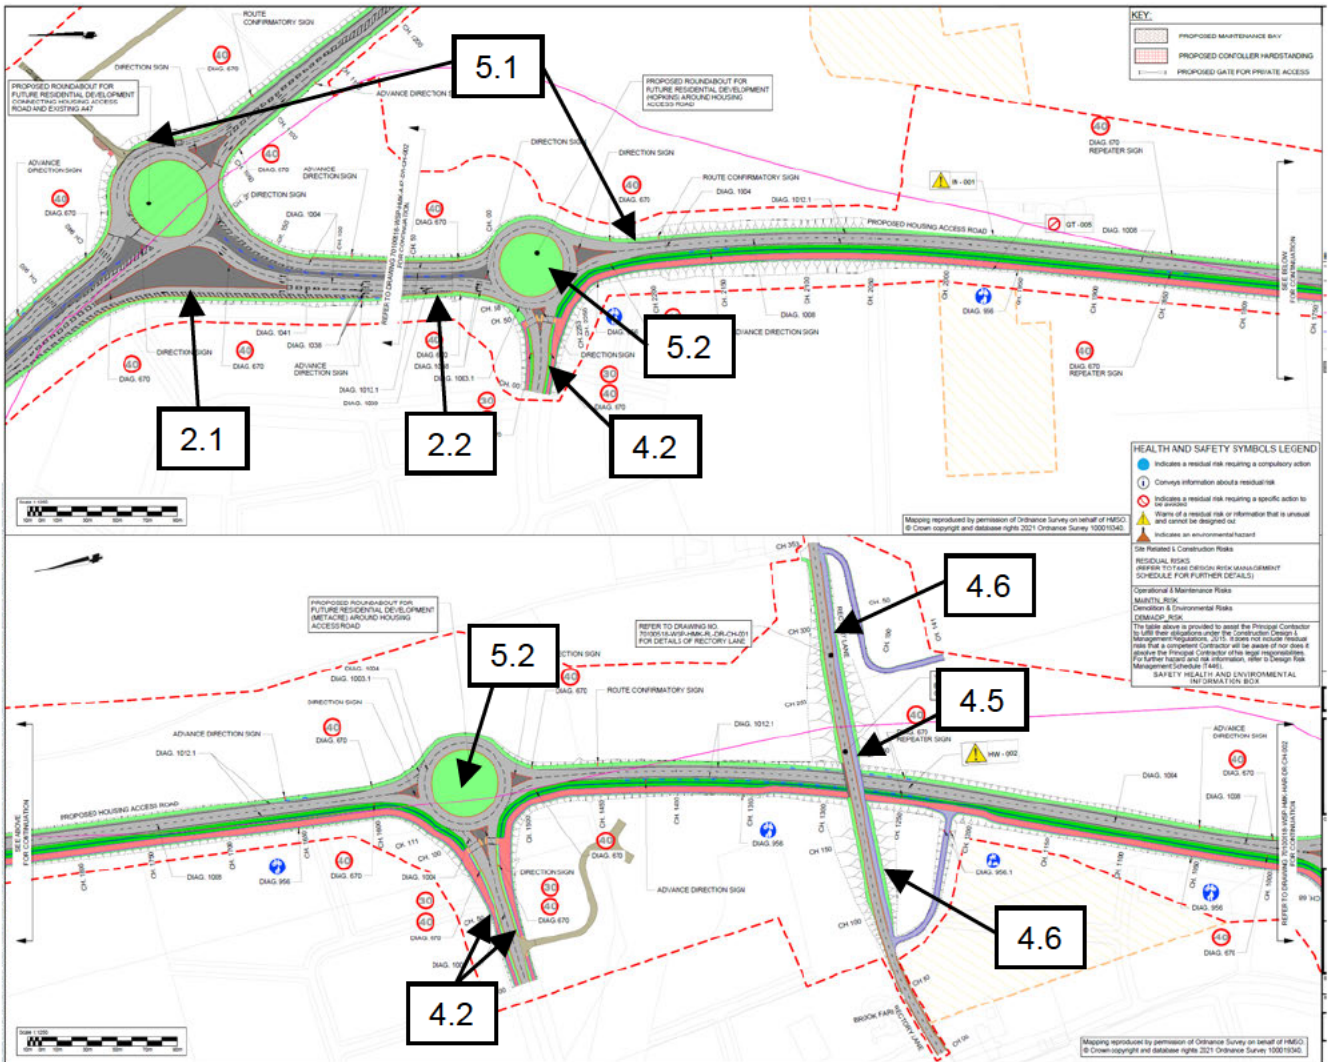
It is understood that a 70kph (40mph) design speed and speed limit have been adopted for the link road. The link road has predominantly straight alignment, albeit broken up by several roundabouts. Furthermore the highway cross section is wide – 7.3m carriageway, 1m hard strips, 5.0m wide swale and 4.0m shared use. With no obvious developed frontage, the audit team is concerned that speed limit compliance will be poor. There may also be marked speed differential between compliant and non-speed limit compliant drivers. Hence, there is an increased risk of speed related collisions (e.g. overtake, tail end collision). Of particular concern are the long uninterrupted lengths of link road south of the Hopkins roundabout.

VRS is proposed extensively throughout the access road to protect roadside hazards. In several instances, this appears appropriate (e.g. at bridge piers), however, there are also situations where VRS is used at point hazards (e.g. speed limit repeater signs, advance directions signs). Whilst roadside hazards should be mitigated, VRS represents a collision hazard in itself and may not be the best solution for all point hazards. Long lengths of VRS also gives an over-engineered appearance at odds with a 40mph design speed (see also 1.1).

Landscaping plans indicate new tree planting in areas where vehicles carry a risk of leaving the carriageway. Vehicle collisions with mature trees carry a high risk of serious or fatal injury for vehicle occupants. Of particular concern are roundabout central islands, the segregated left turn island at A47, and trees at roundabout exits.

No details have been provided regarding detailed roundabout geometry. Of particular concern is lack of detail for entry path curvature which is a key determinant of roundabout safety as it directly affects the entry and circulatory speed for a roundabout. However, other geometric features such as entry and exit kerb radii, circulatory width and landscaping can also influence the safe operation of a roundabout.

1.1, 1.2, 1.3, 2.4 – Throughout the housing access road

Recommendation – it is recommended that the highway cross section is reduced to a lower standard more in line with a 70kph design speed and/or speed management measures introduced.

Recommendation – Where possible, it is recommended that single point hazards (e.g. traffic sign posts) are specified as passively safe as an alternative to long lengths of VRS.

Recommendation – It is recommended that any trees which have the potential for a trunk girth greater than 250mm are not planted in the above high risk areas. Roadside trees on links to be set back at least 4.5m from the carriageway edge.

Recommendation – It is recommended that roundabout geometry is subject to safety audit prior to detailed design.
