# Sheringham Waste Recycling Centre Holt Road Norfolk

**Flood Risk Assessment and  
Surface Water Drainage Strategy  
March 2024**

On behalf of **Norfolk County Council**

Project Ref: 332249868/4001 | Rev: R5 | Date: March 2024

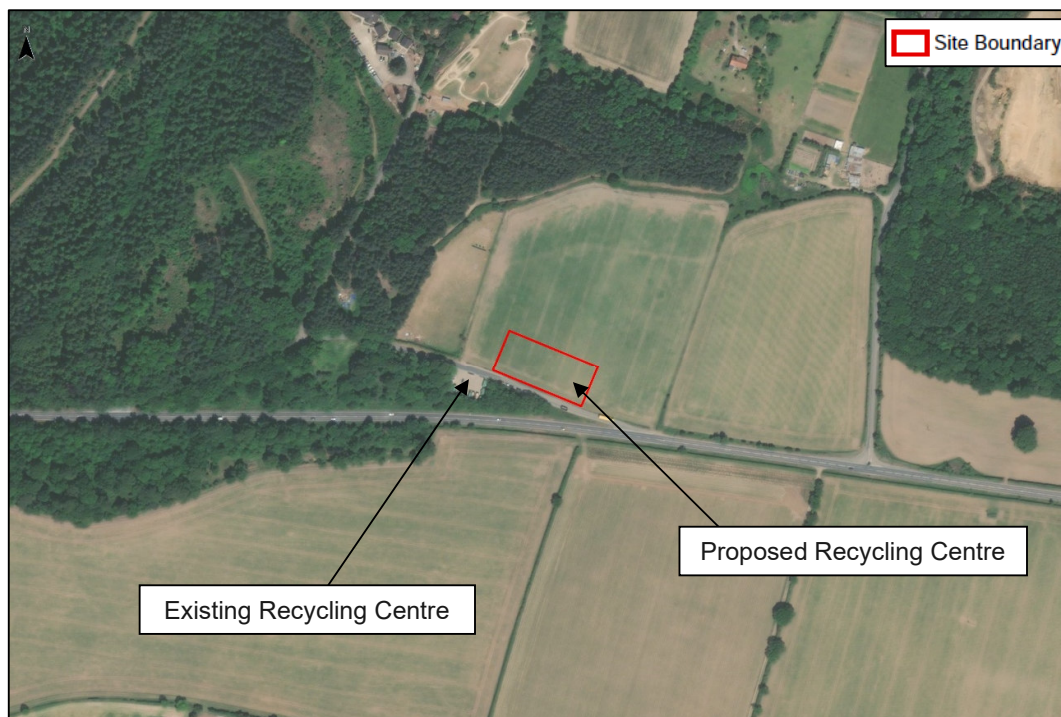
**Figure 2.1: Location Plan**

- 2.1.1 The existing Sheringham Recycling Centre (approximately 600m<sup>2</sup>) is operated by Norfolk County Council and located south of Holt Road, East Beckham, Sheringham, NR26 8TW.
- 2.1.2 The proposed relocation site (the 'Site') is located immediately northeast of the existing recycling centre, on the northern side of Holt Road, as shown in Figure 2.1 below. The Ordnance Survey grid reference for the centre of the site is E616271, N341031. A site location plan is included in **Appendix A**.
- 2.1.3 The site currently comprises 0.366 hectares (ha) of cultivated agricultural land and is bound to the north, east, south, and west by woodland and agricultural land.

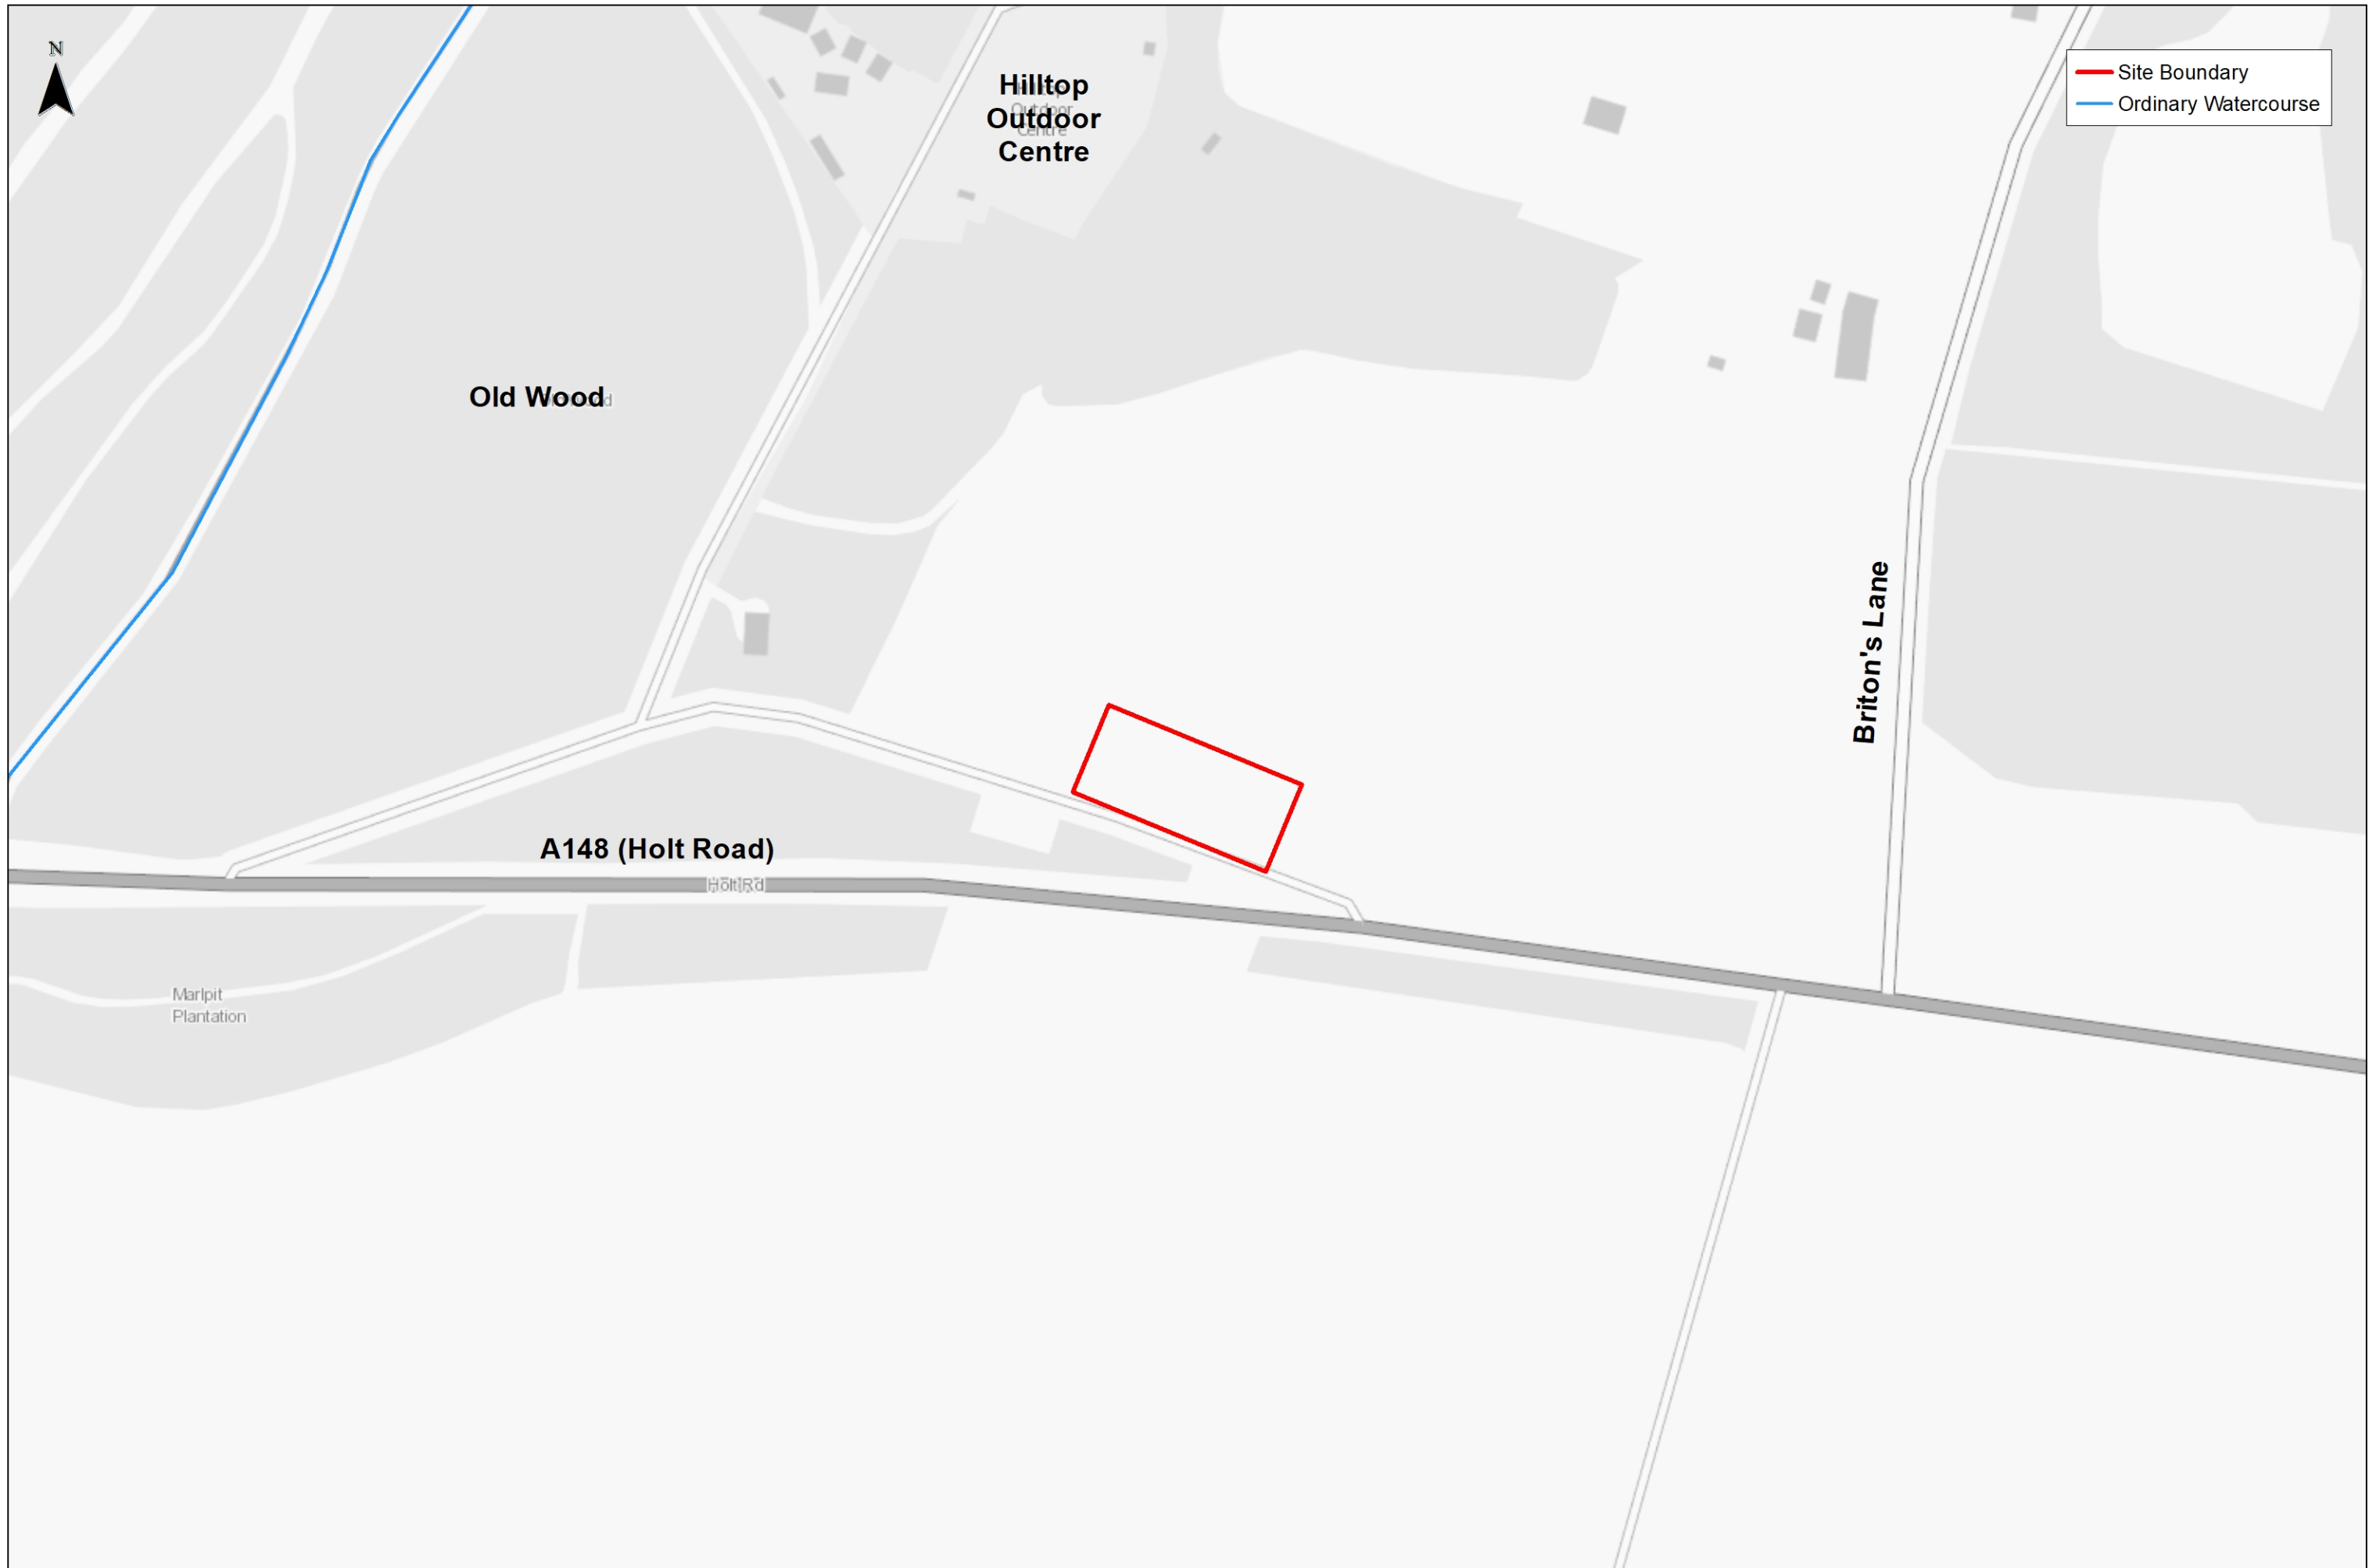
1:2,500 @ A3	Date: 25/02/2021
Drawn: MD	Checked: RL
Figure 49868/4001/GIS001a	Rev A

**SHERINGHAM RECYCLING CENTRE**  
 Site Location

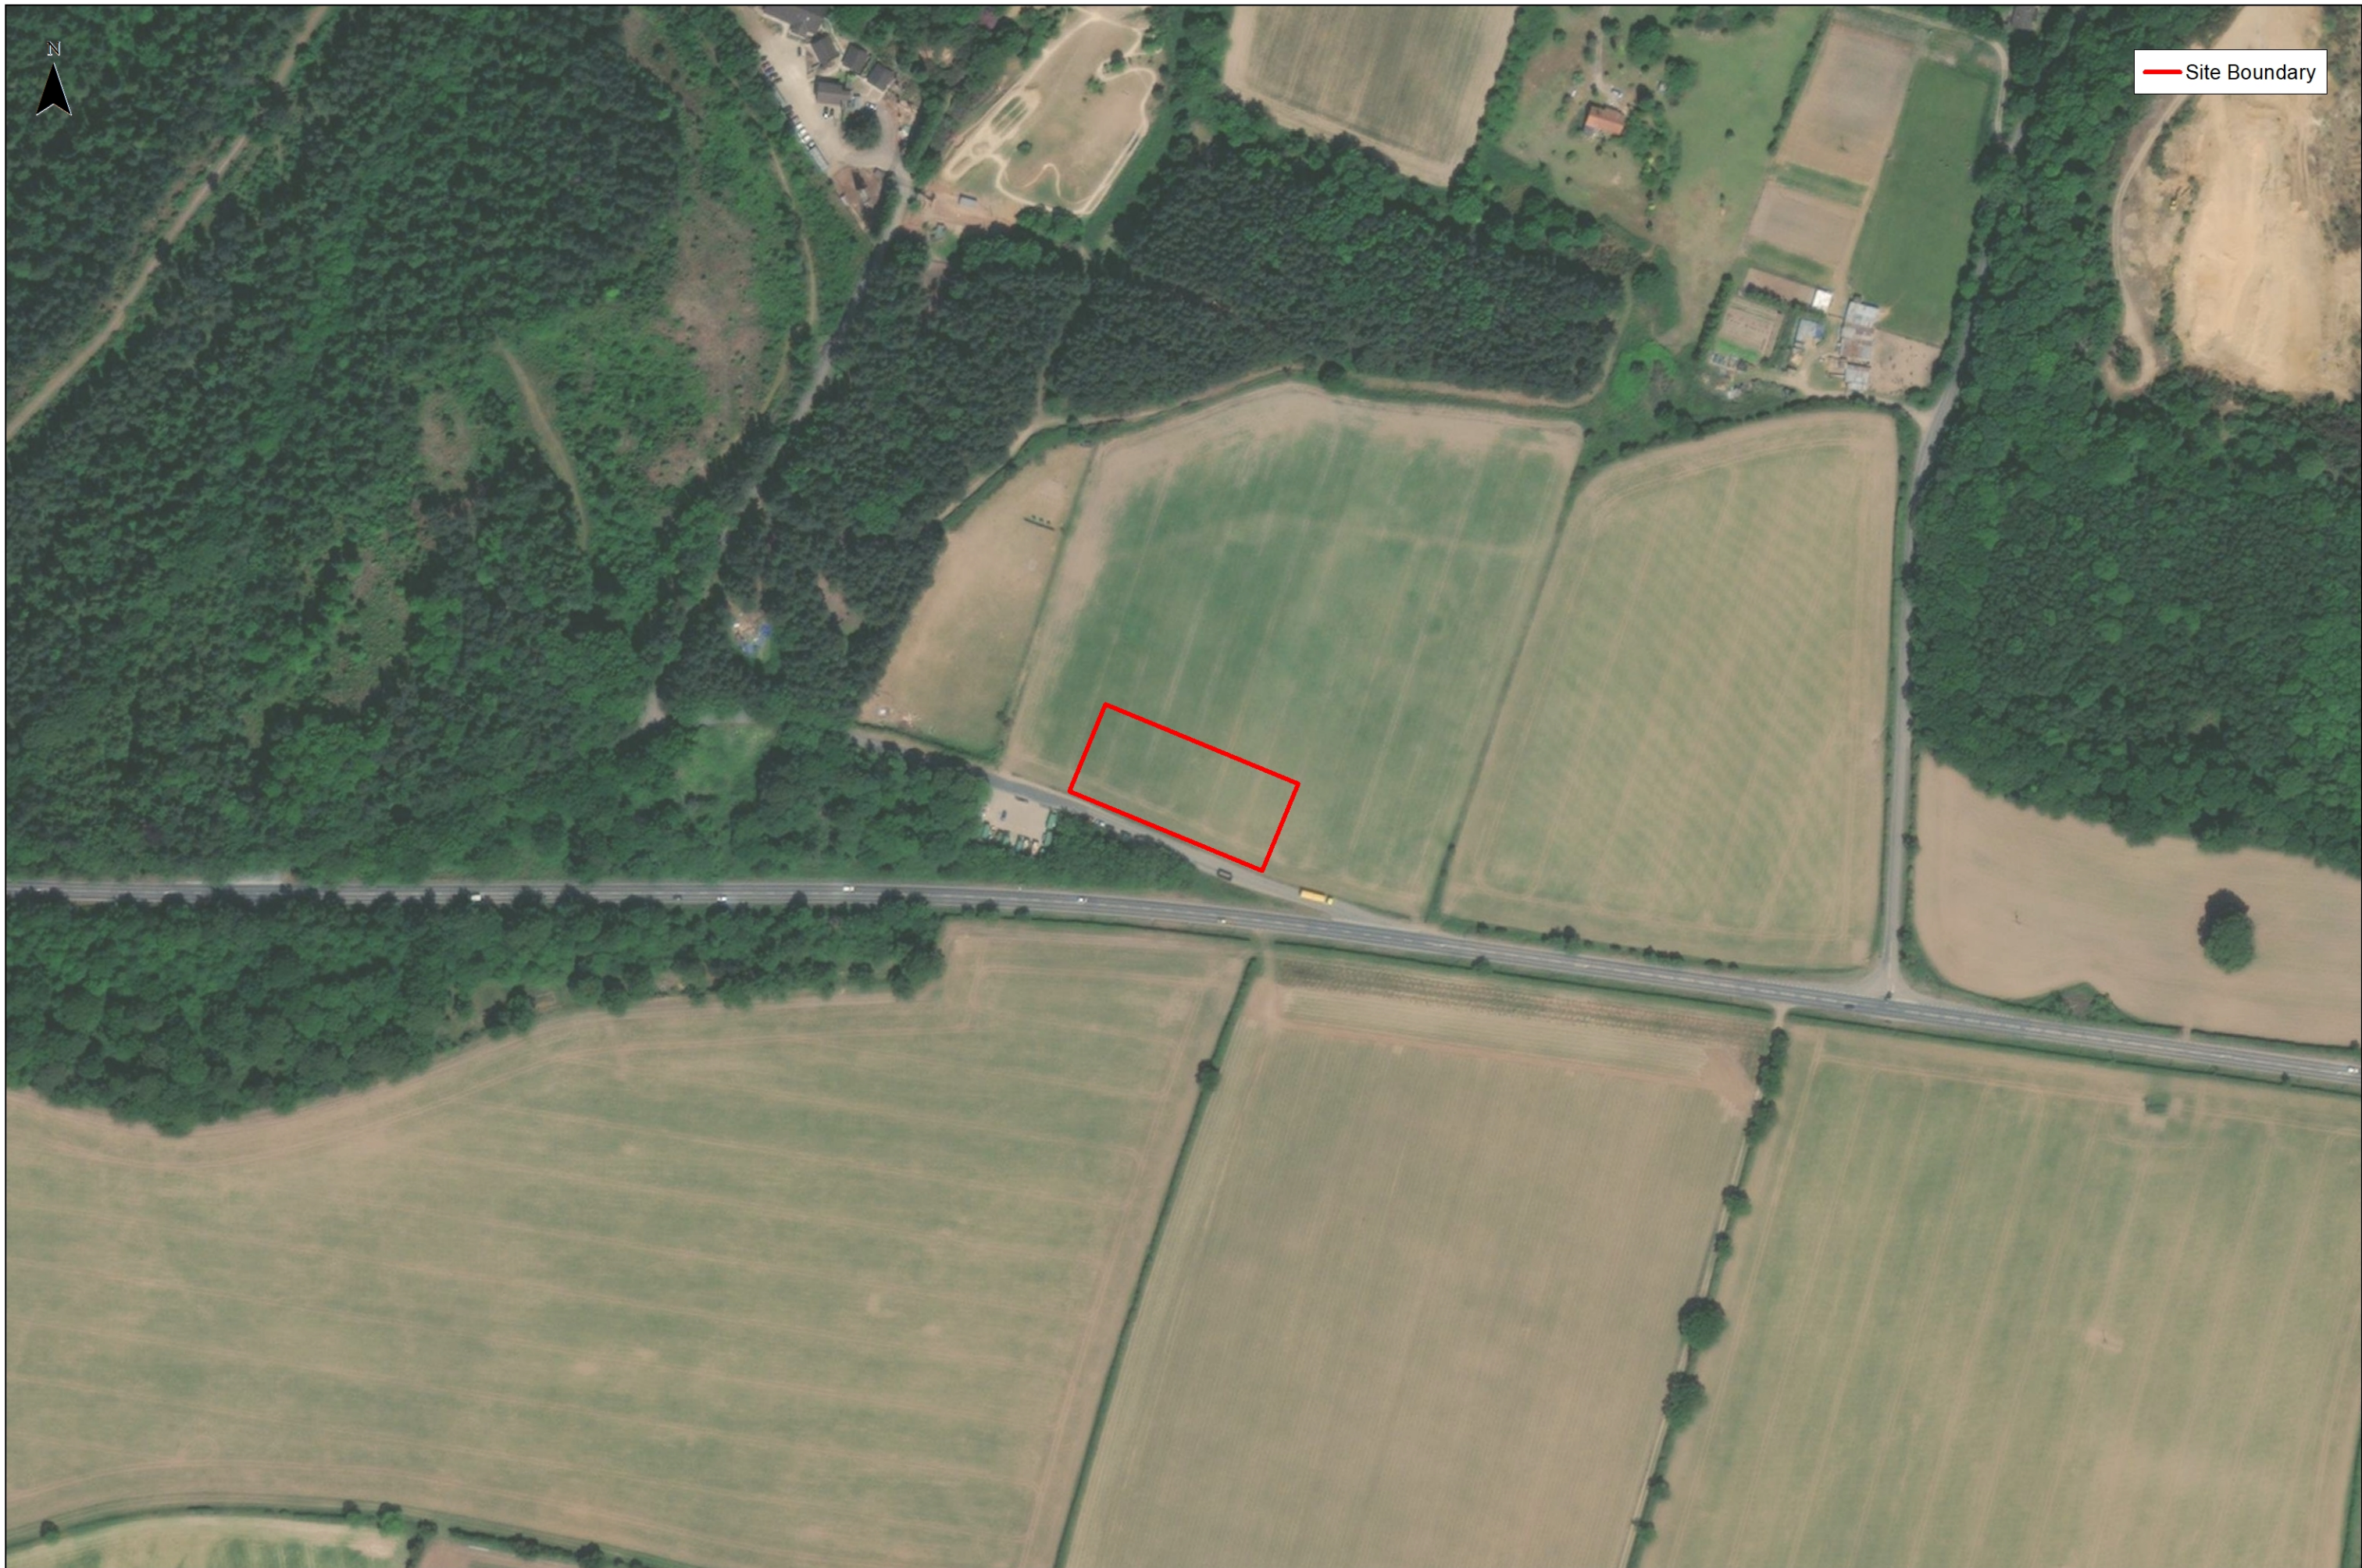
Figure 49868/4001/GIS001b Rev A

**SHERINGHAM RECYCLING CENTRE**  
Site Location (Aerial)

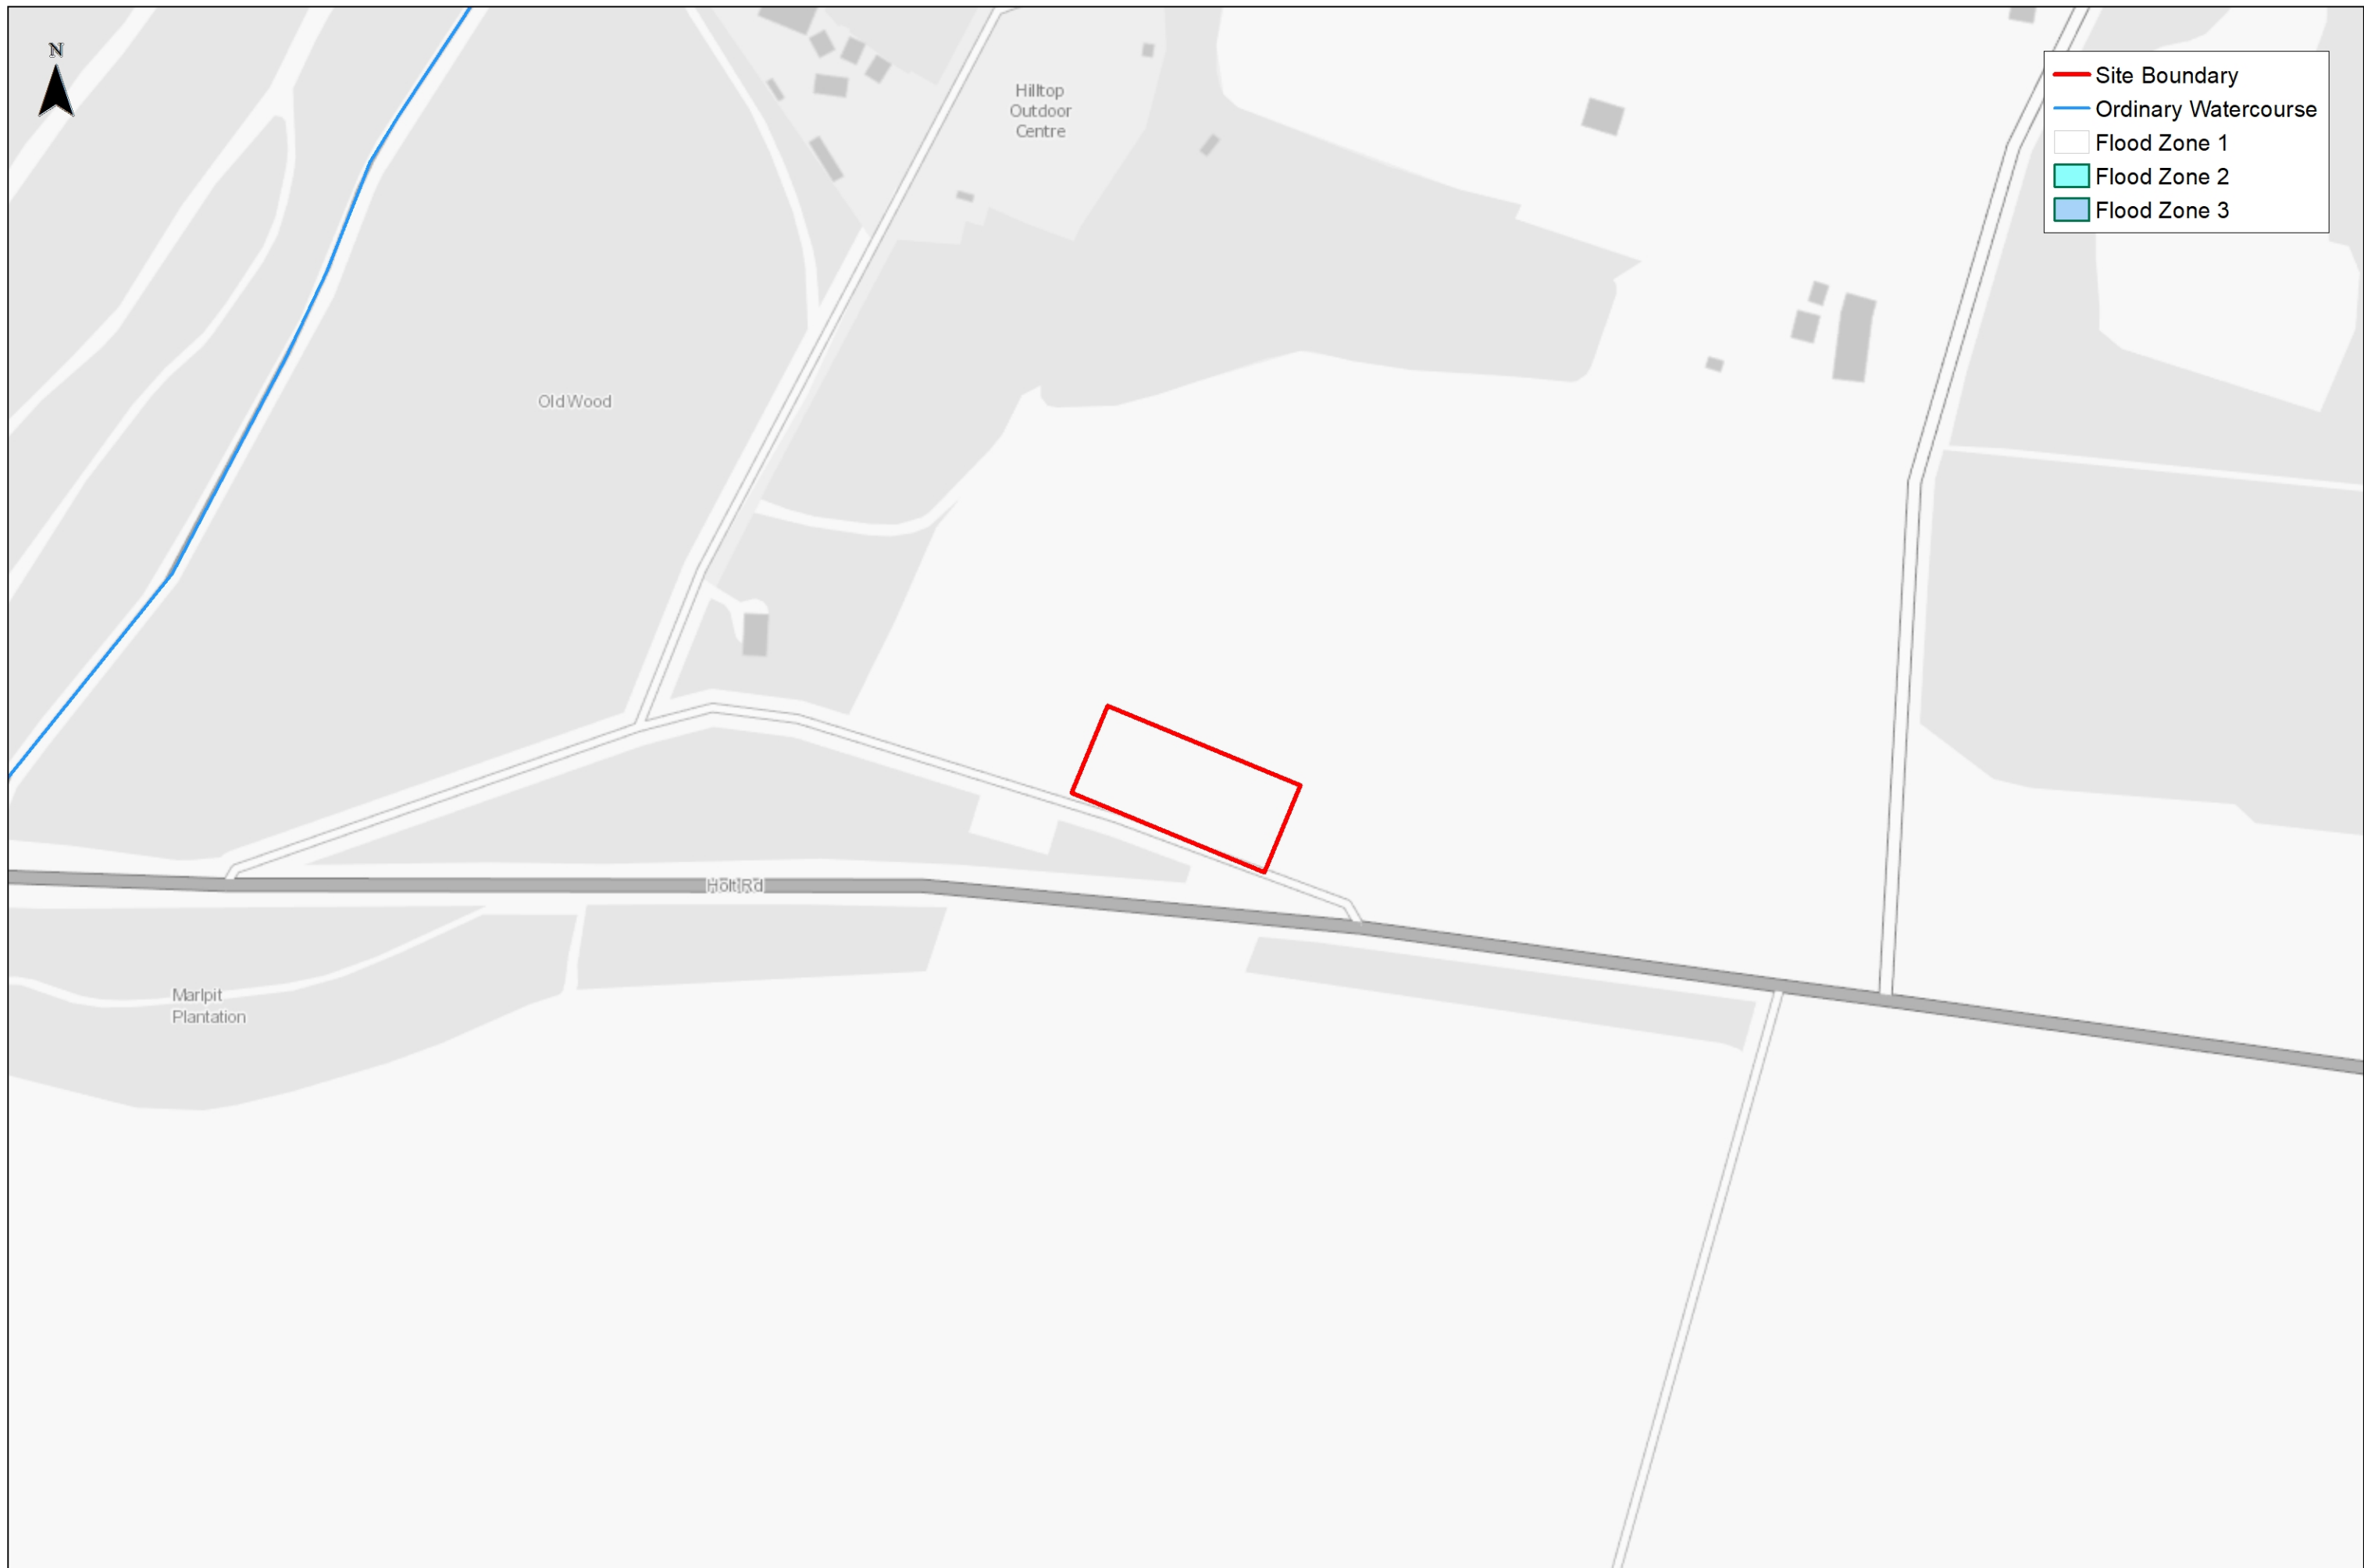
Figure 49868/4001/GIS003 Rev A

**SHERINGHAM RECYCLING CENTRE**  
Environment Agency Flood Zones for Planning

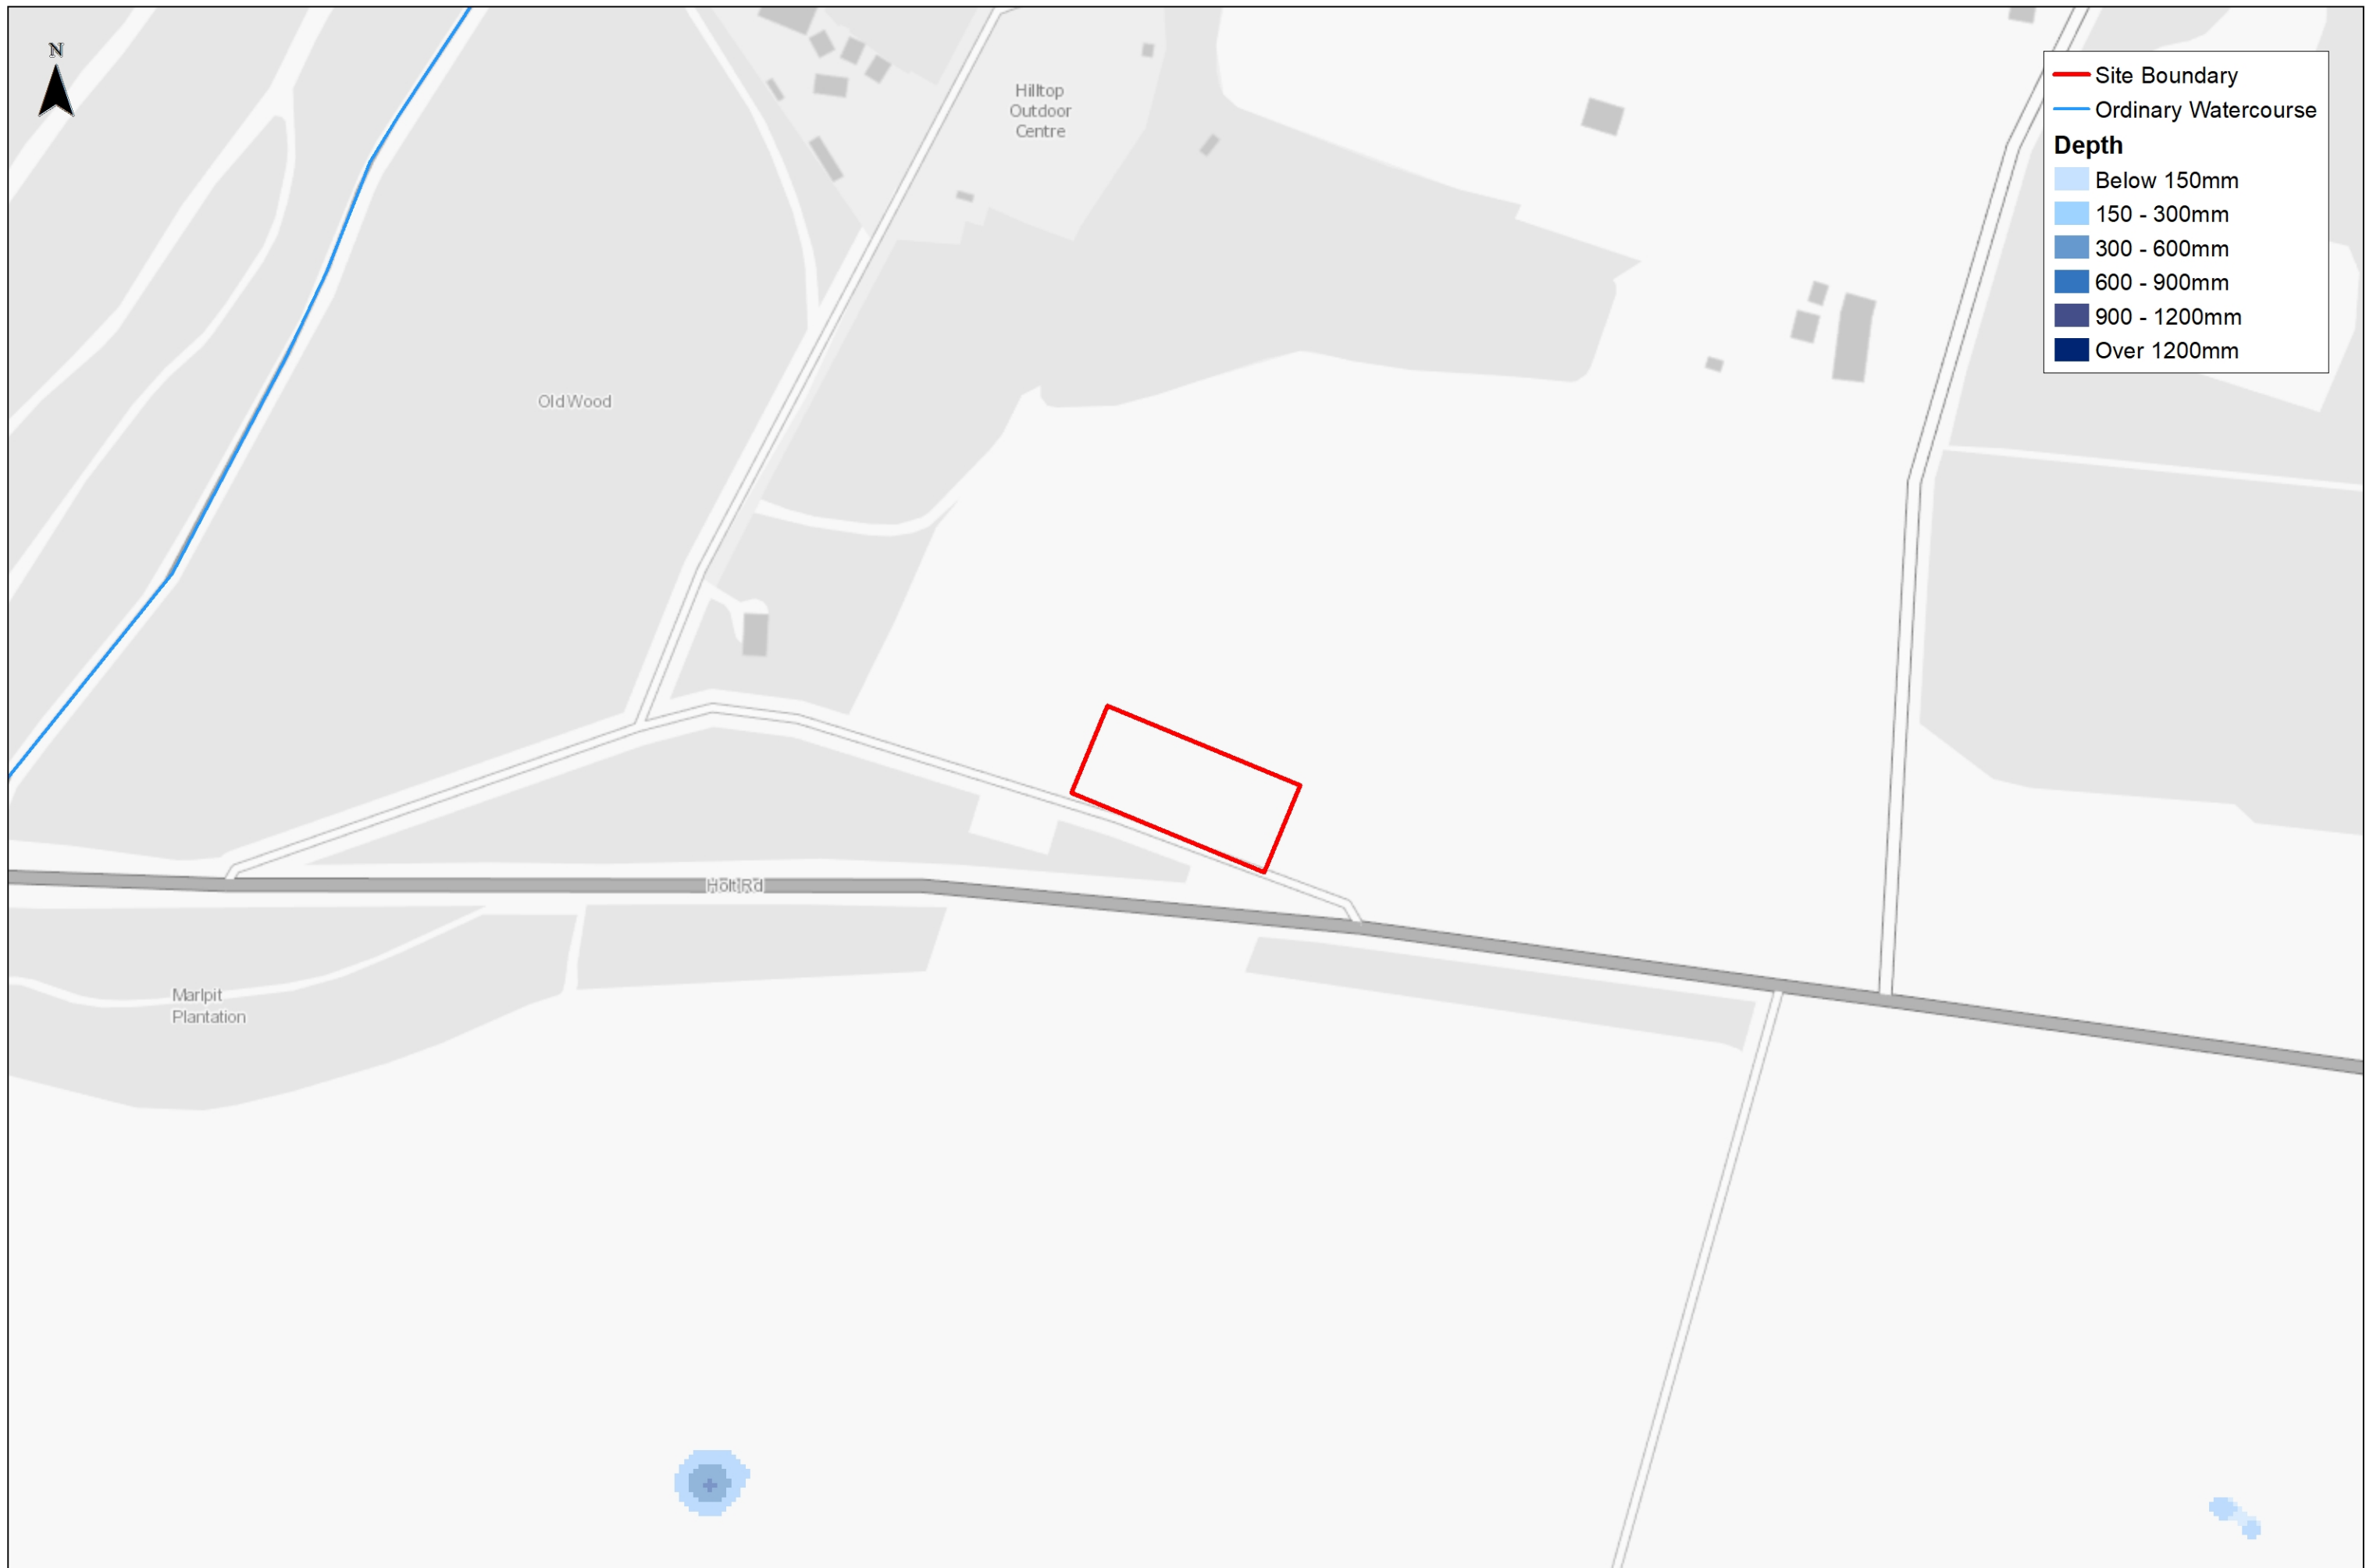
1:2,500 @ A3	Date: 25/02/2021
Drawn: MD	Checked: RL
Figure 49868/4001/GIS005	Rev A

— Site Boundary  
— Ordinary Watercourse  
**Depth**  
 Below 150mm  
 150 - 300mm  
 300 - 600mm  
 600 - 900mm  
 900 - 1200mm  
 Over 1200mm

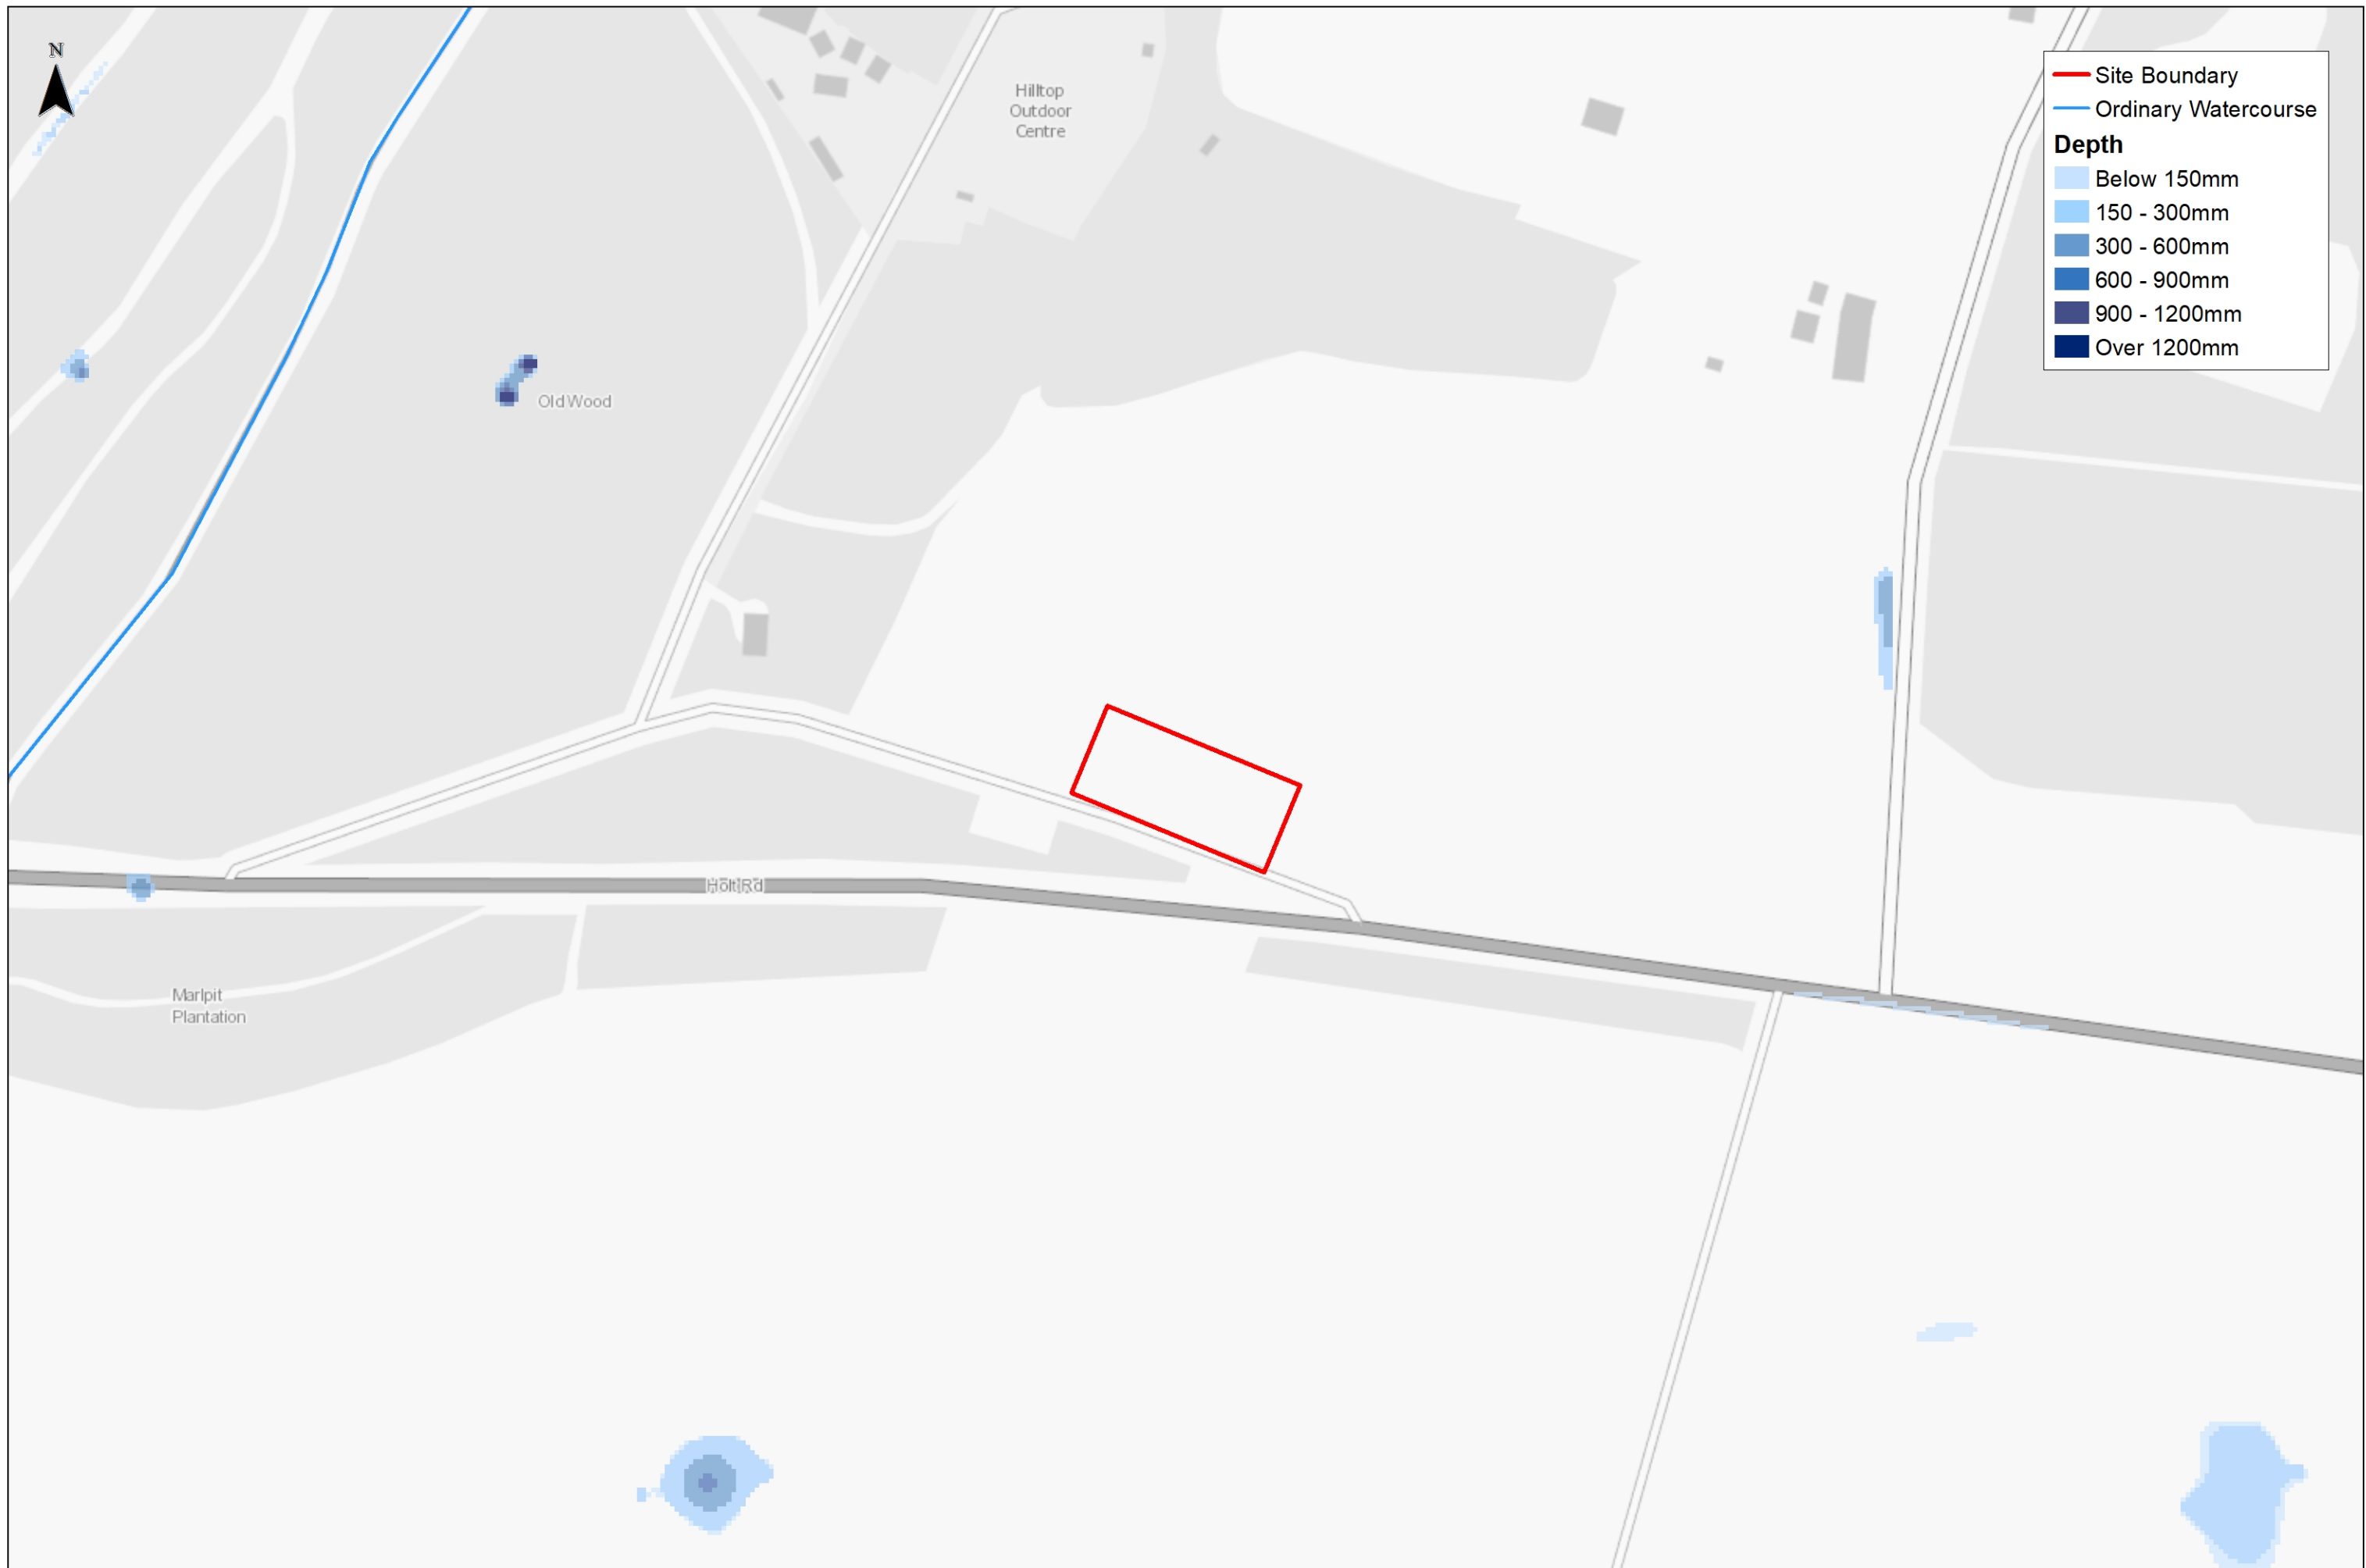
1:2,500 @ A3	Date: 25/02/2021
Drawn: MD	Checked: RL
Figure 49868/4001/GIS009	Rev A

— Site Boundary  
— Ordinary Watercourse  
**Depth**  
 Below 150mm  
 150 - 300mm  
 300 - 600mm  
 600 - 900mm  
 900 - 1200mm  
 Over 1200mm
