# Sheringham Waste Recycling Centre Holt Road Norfolk

**Flood Risk Assessment and  
Surface Water Drainage Strategy  
March 2024**

On behalf of **Norfolk County Council**

Project Ref: 332249868/4001 | Rev: R5 | Date: March 2024

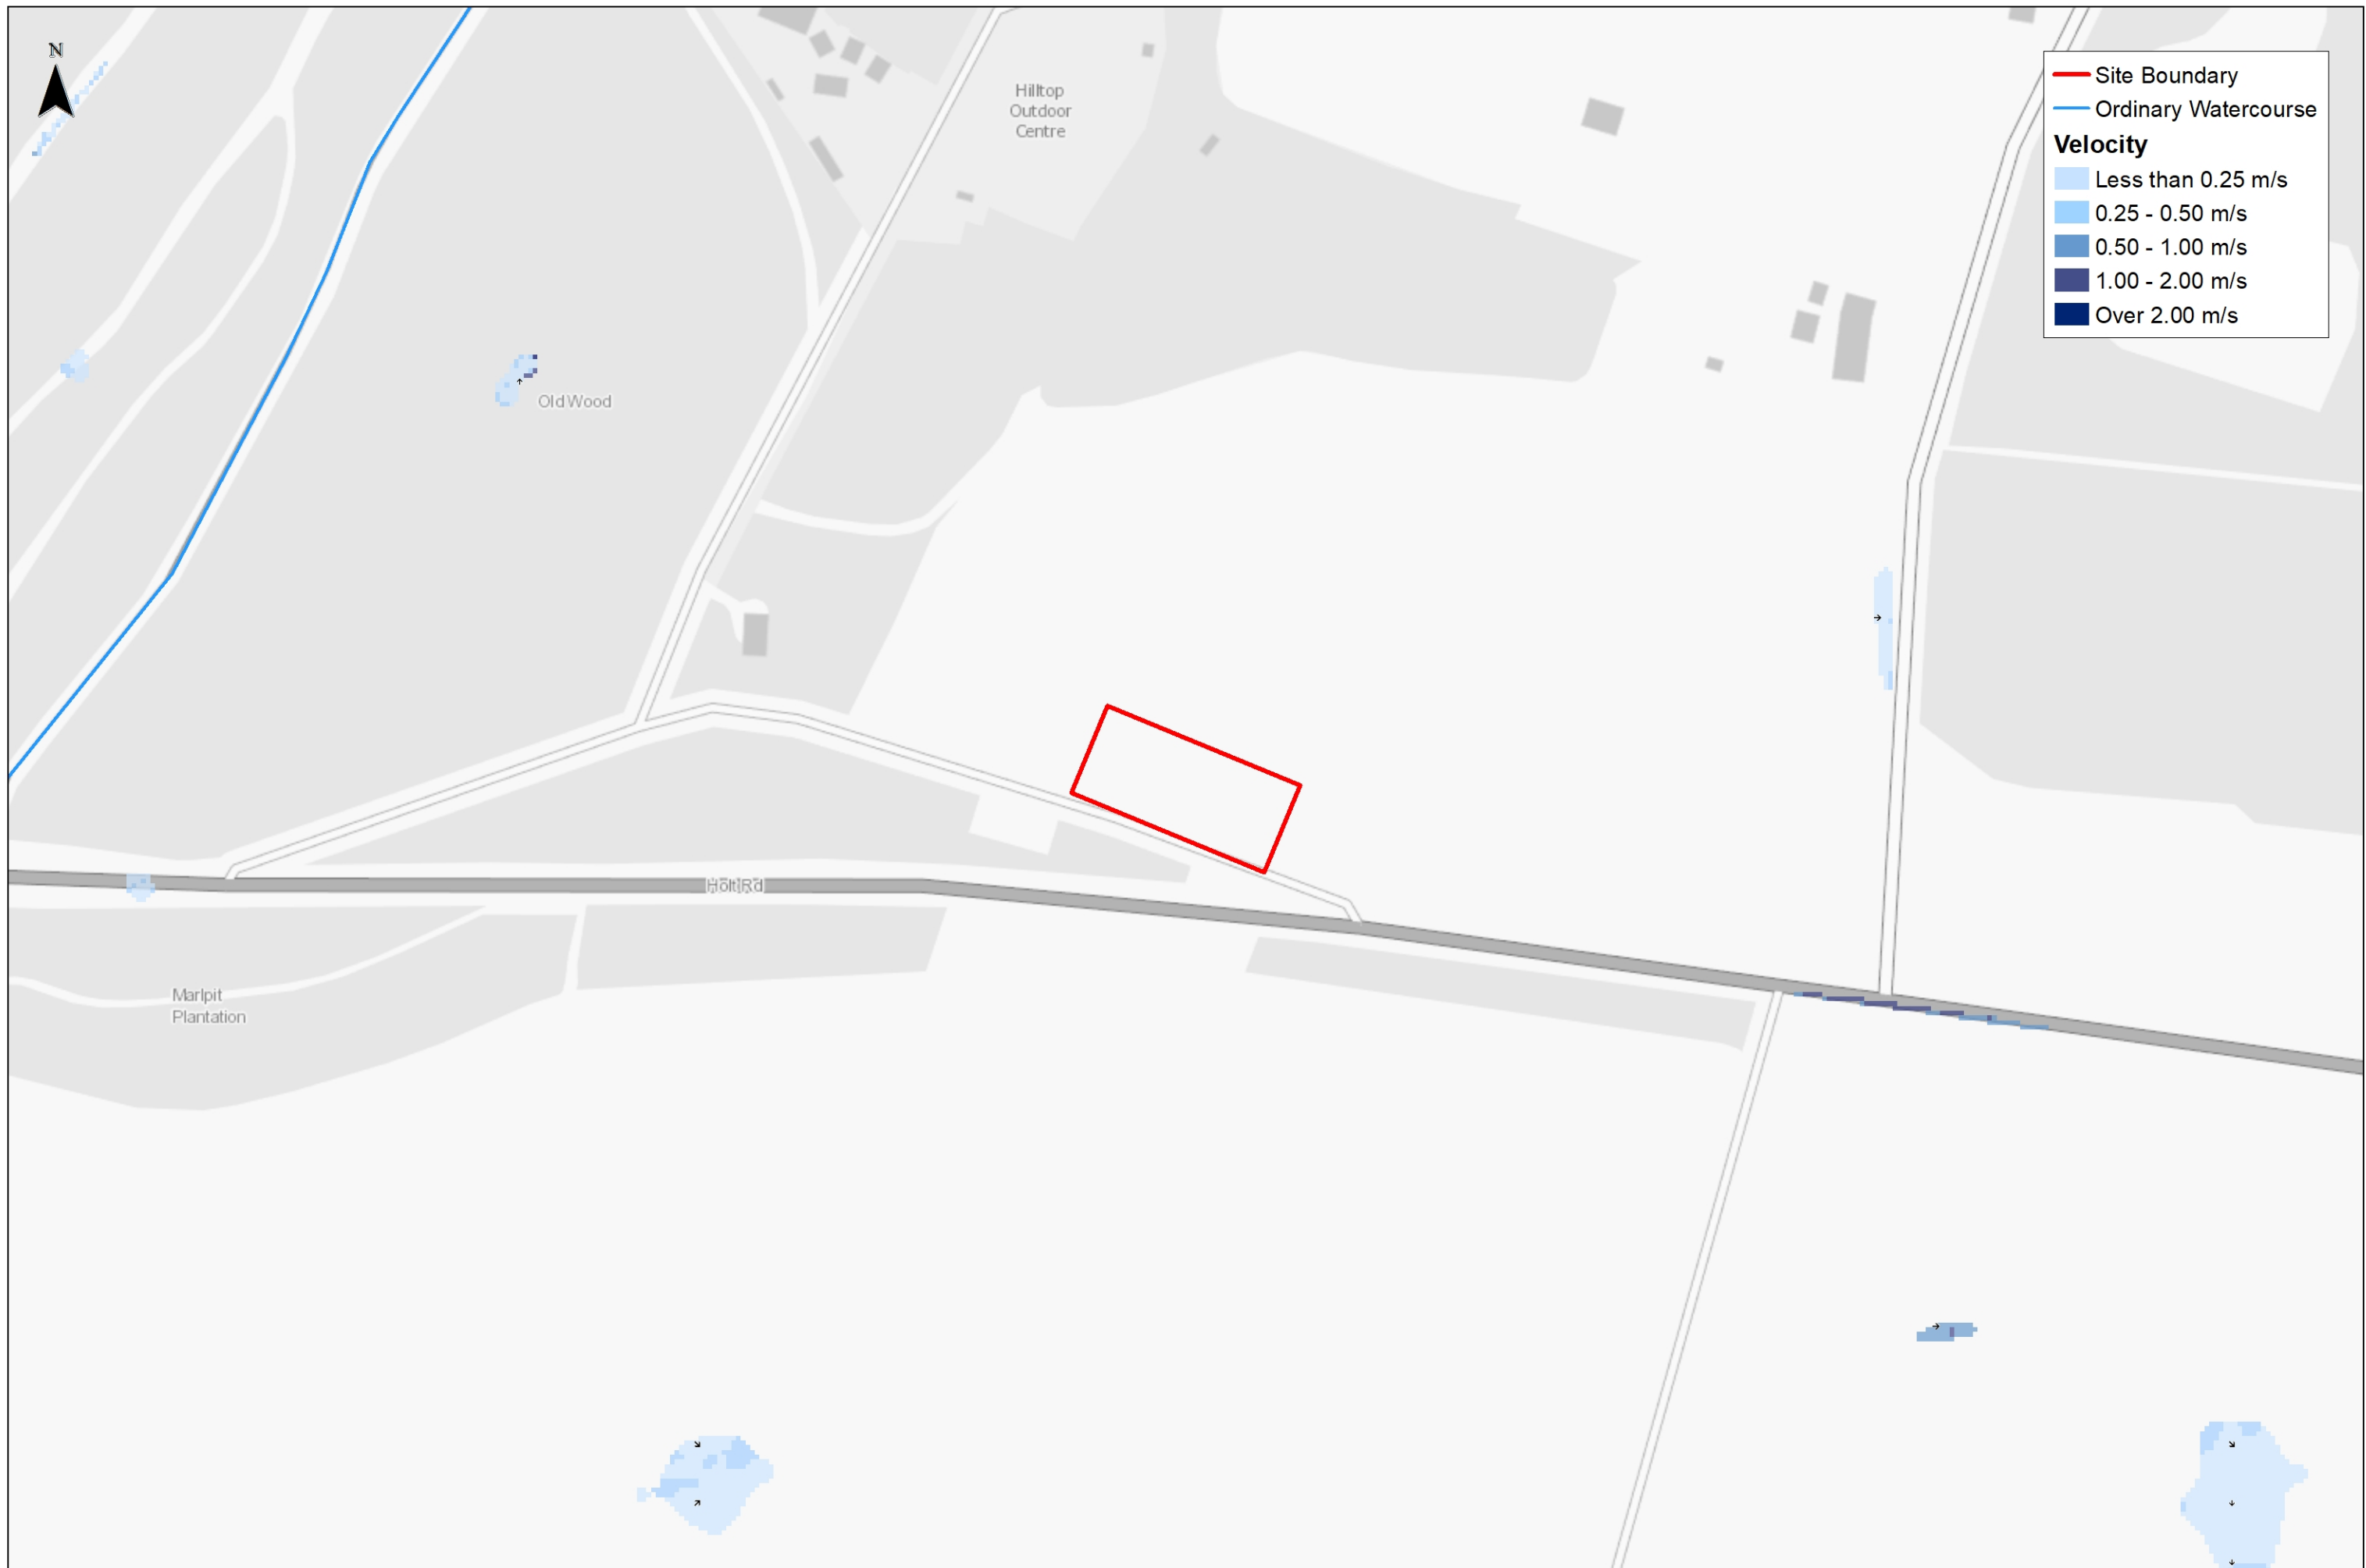
Figure 49868/4001/GIS010 Rev A

**SHERINGHAM RECYCLING CENTRE**  
Flood Risk from Surface Water  
(Low Risk Velocity)

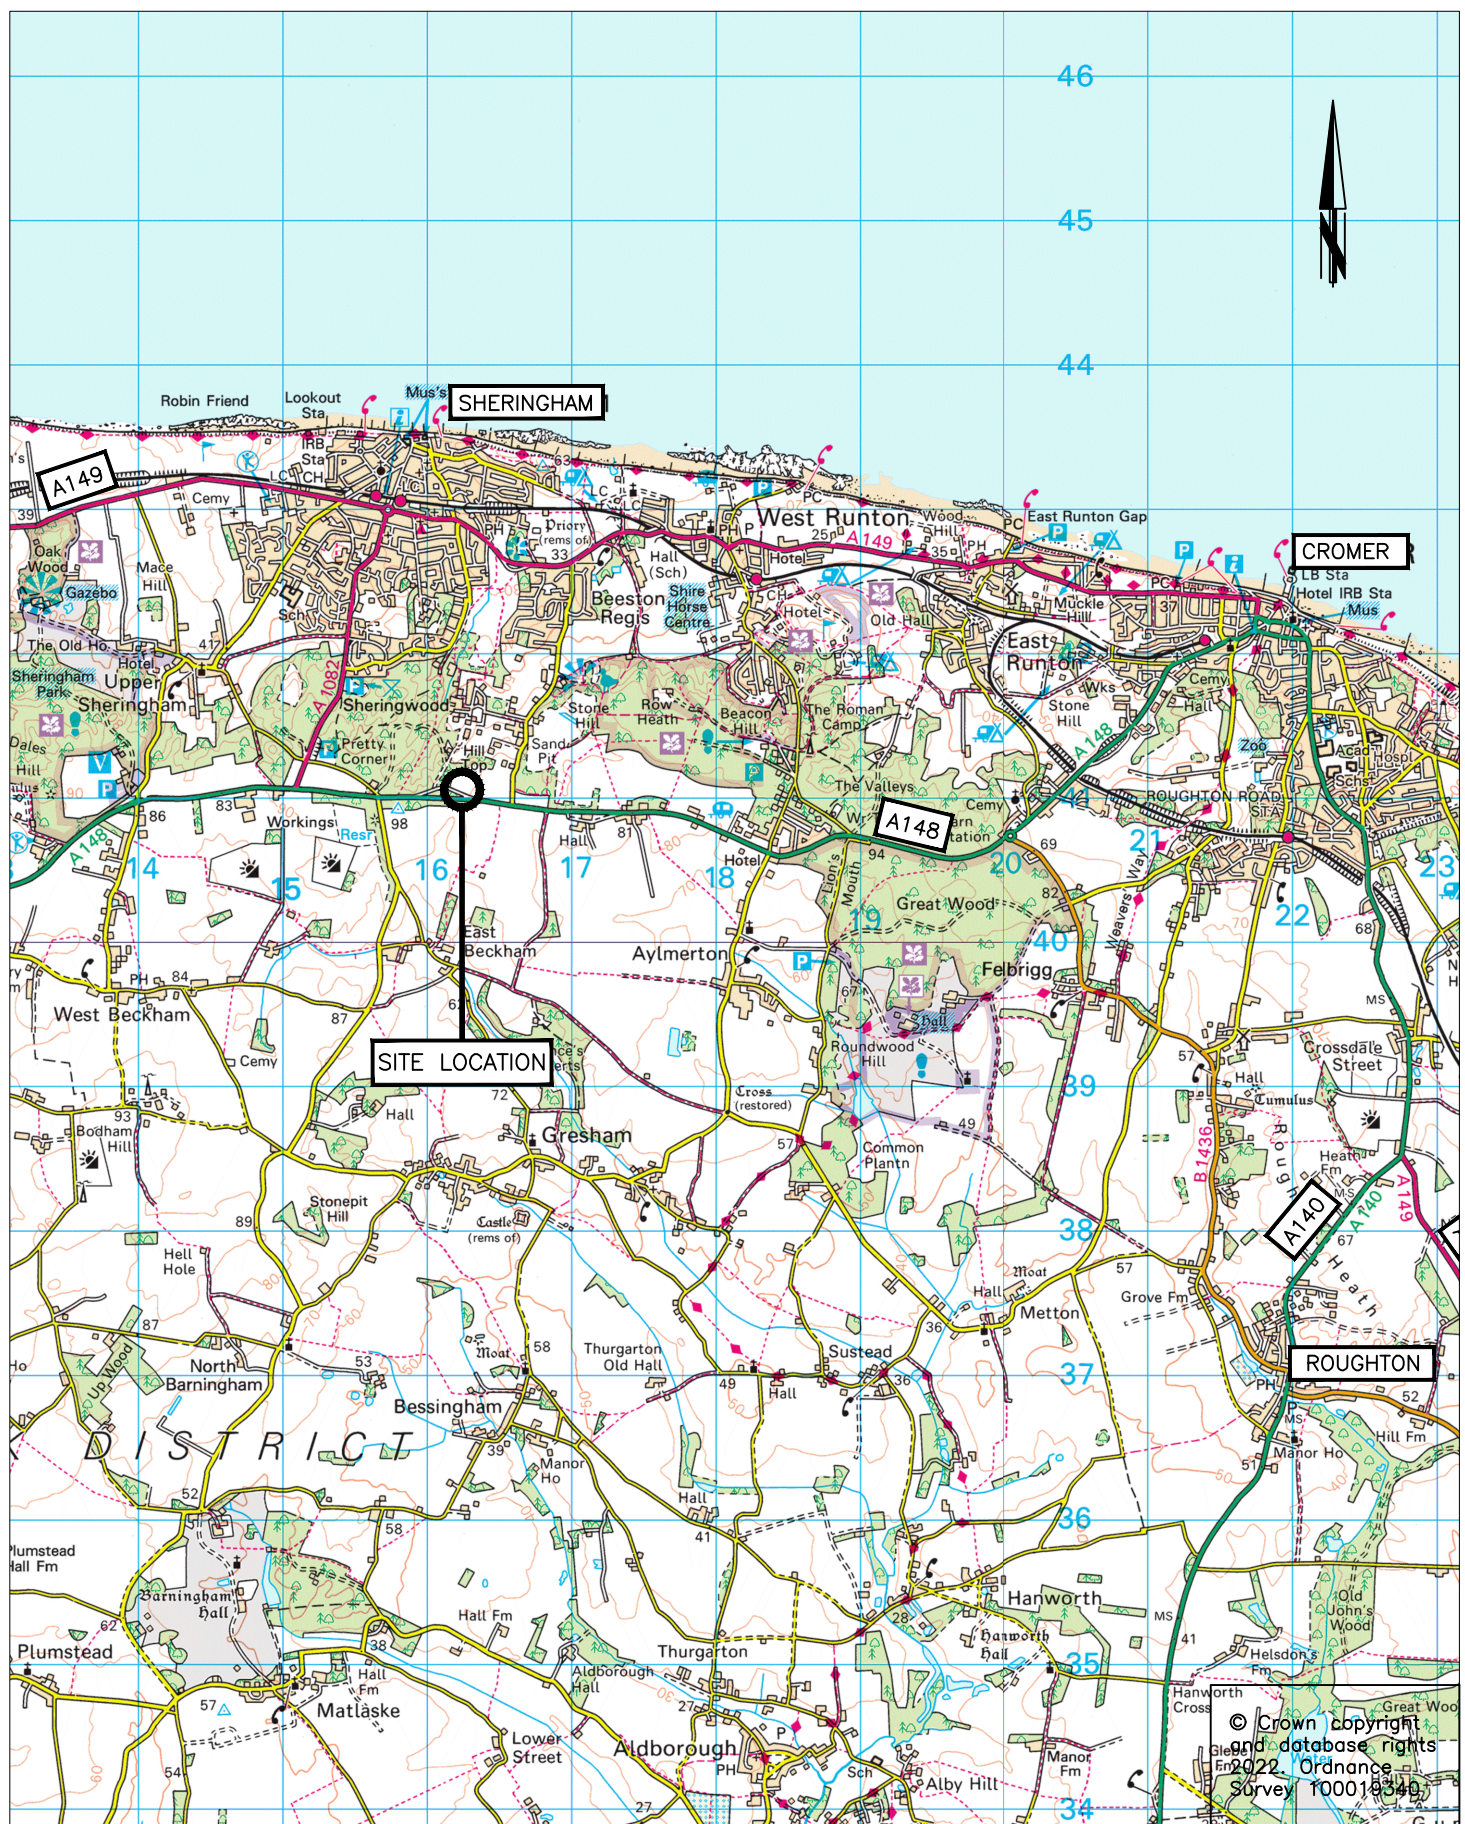
SHERINGHAM HWRC  
GROUND INVESTIGATION  
SITE LOCATION PLAN

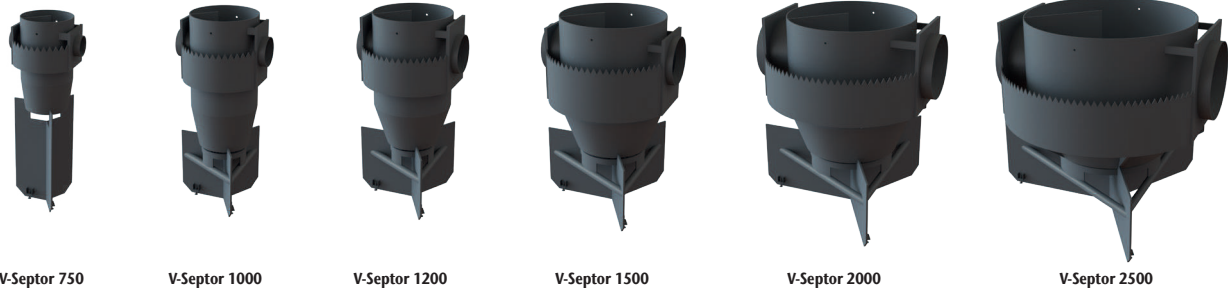
Product name	Product code	Chamber diameter (A)	Pipe connections (B)	Top to invert (C)	Sediment storage capacity	Oil / debris storage capacity	Typical treatment flow rate (fine)	Typical treatment flow rate (coarse)	Typical non remobilisation flow rate (coarse)
		mm	mm	mm	m <sup>3</sup>	l	l/s	l/s	l/s
<b>ACO V-Septor - Hydrodynamic Separator Range</b>									
V-Septor 750	40995	750	150	375	0.4	49	11	14	37
V-Septor 1000	41000	1050	225	483	0.6	335	20	25	67
V-Septor 1200	41003	1200	300	550	0.86	397	29	37	98
V-Septor 1500	41005	1500	375	608	1.2	785	45	57	151
V-Septor 2000	41009	2100	500	700	2.2	1130	80	102	269
V-Septor 2500	41013	2400	600	850	3.5	2010	125	159	421
