## SWAFFHAM SEN

### Swaffham Sen Feasibility.Docx

26 September 2023

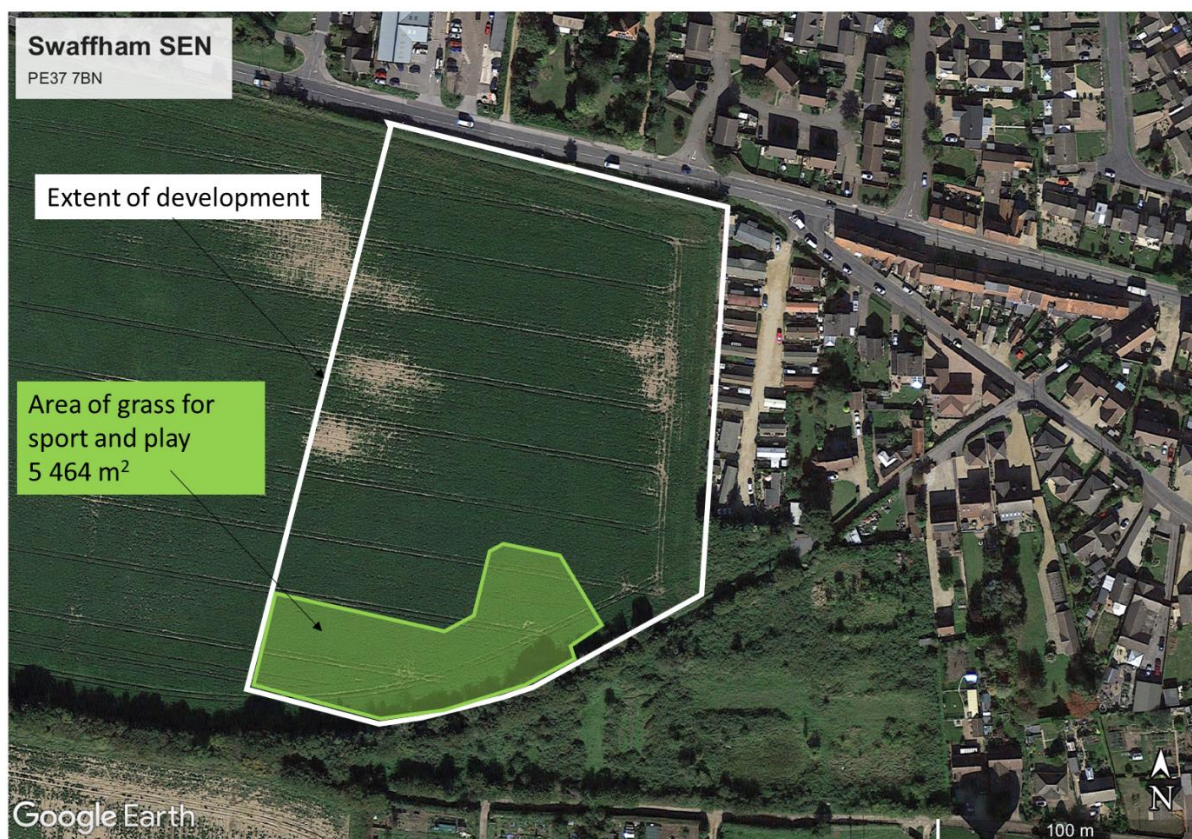
Figure 1-2 Contemporary Google Earth image of the site with grassed areas shown in outline

The grassed area shown occupies approximately 5 464 m<sup>2</sup> (0.5464 ha, 1.35 acres, 0.005464 km<sup>2</sup>).

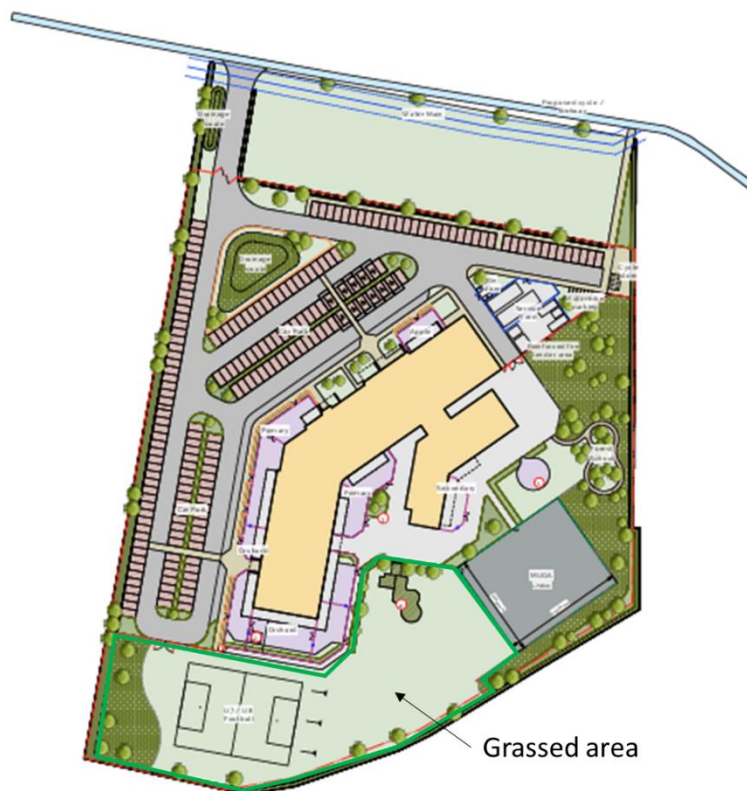
Figure 1-3 Grassed area in proposed layout<sup>1</sup>

A topographic survey of the site was not available. It could be discerned, however, that the land falls to the north-west of the area with which we are concerned with a slight fall to the west. The highest point of the development area is in its south-west corner, corresponding with the location for the small side football pitch (Figure 1-3).

The proposed layout (Figure 1-3) indicates a new bell-mouth entrance directly off Lynn Road to the north. Prior to the construction of this, no alternative vehicular access is readily available.

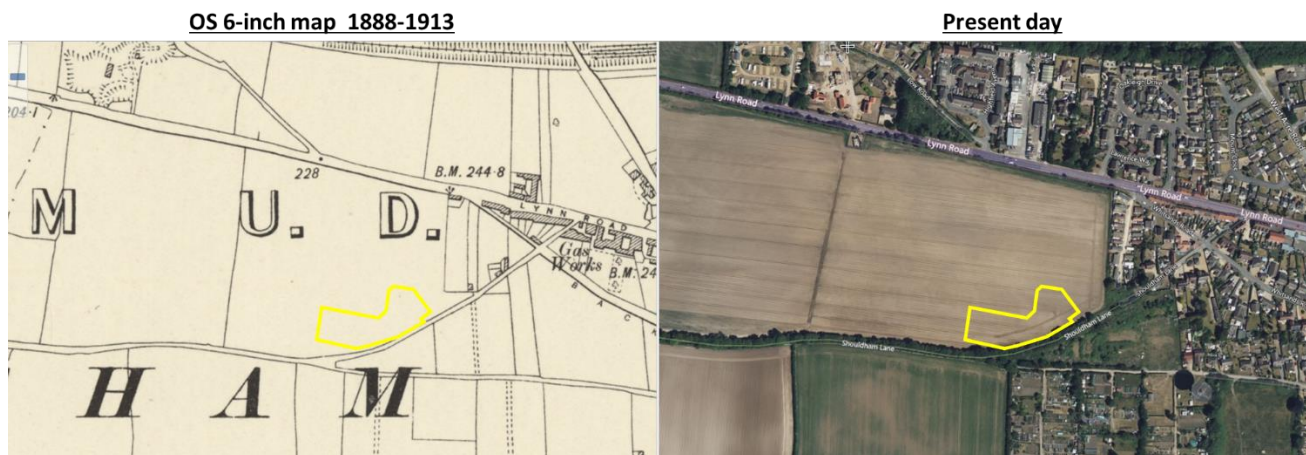
The area with which we are concerned has almost certainly maintained as arable agricultural fields for centuries. The outline of the grassed area of the site is shown in the historic map from the late 19<sup>th</sup> century alongside the current image of the site in Figure 1-4.

Figure 1-4 Outline of the grassed area of the site on OS 6-inch map 1888 – 1913 (left) and on contemporary image

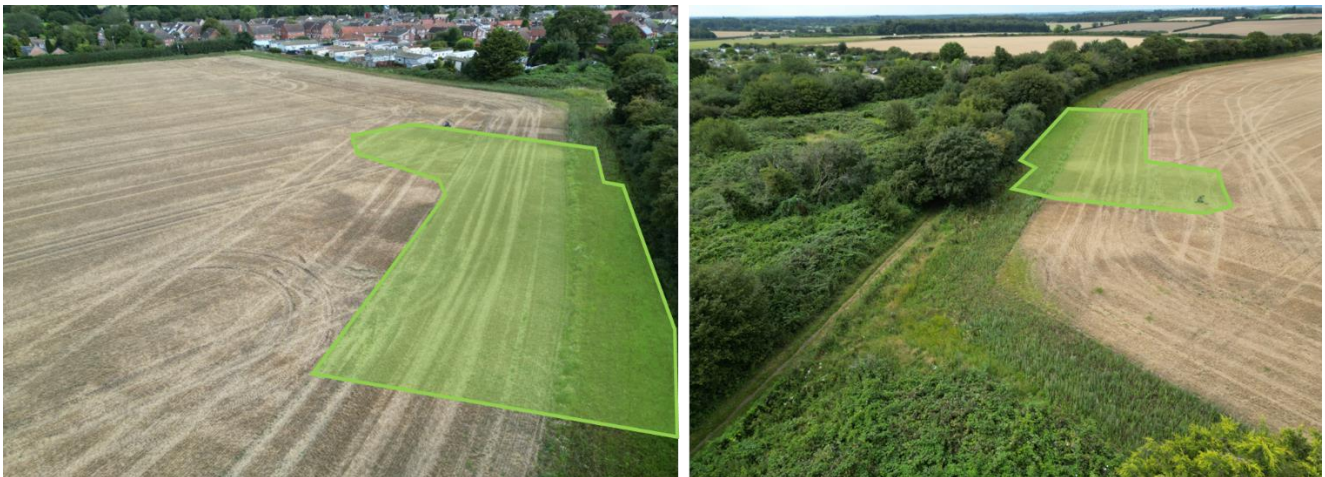
Figure 3-1 Views from west (left) and east across the site with approximate outline of the grassed area

To the north of the development site is Lynn Road, and to the east is an area providing caravan or semi-permanent accommodation. To the south is a public footpath with an area of woodland and scrub beyond. To the west, the arable field of which the site is composed extends over some considerable distance. The sport and play area is to the south of this development area.

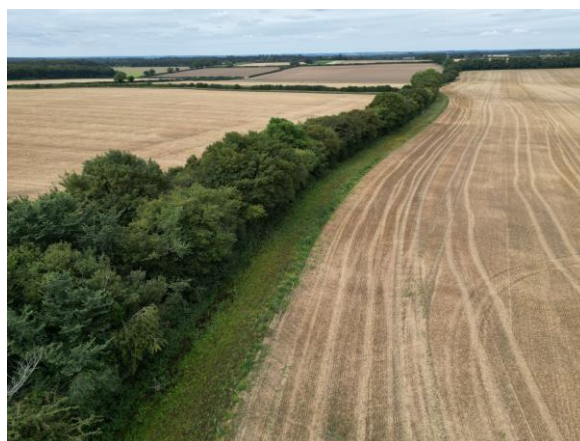
Unmaintained hedgerow and small trees run along the southern and northern boundaries. Along the edge of the arable land, an area of set-aside extends around 5 metres into the development area.

Figure 3-2 Southern boundary of the development site and of the grassed area

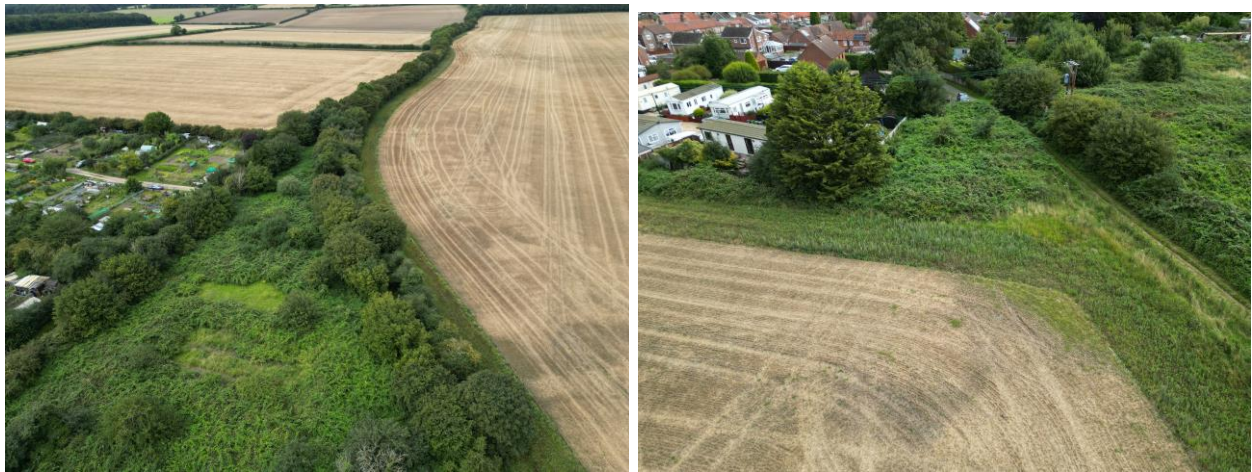
**Figure 3-3 Westward view across the southern extent of the development area (left) and the south eastern corner offering limited opportunities for access**

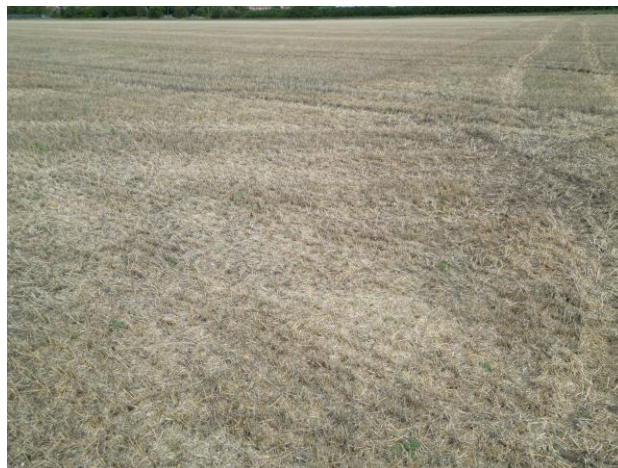
**Figure 3-4 Typical appearance of ground cover at the time of the investigation**

At the time of the investigation the grain crop had been harvested and the remaining vegetation cut down to around 100 mm height.

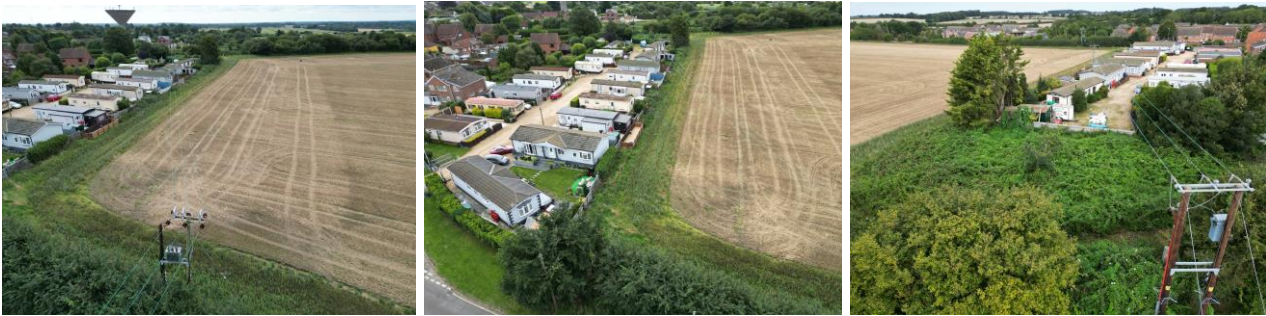
Overhead power lines run from approximately 30 metres west of the north-eastern corner of the development site to the south east corner. However, these do not pass over the area of the natural turf preparation.

Figure 3-5 Overhead power lines at the north east side of the development site
